Technical Bulletin / Safety Alert

Unique ID No: DES2009-TBSA-03

Subject: Inlet Flametrap Alteration to MDR090376DES & MDA DES 13017

Date: 12/11/2012

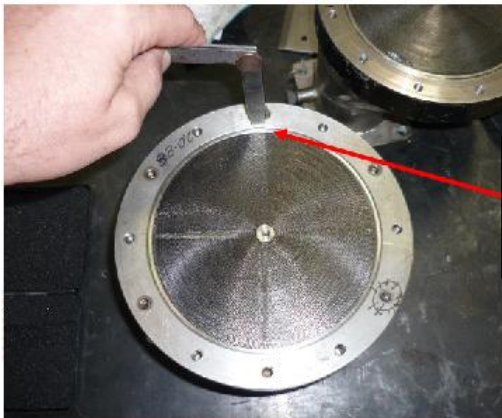
As a result of the abovementioned expiries, the Inlet Flametrap flamepath gap for all diesel engine systems covered under design registration MDR090376DES and approval MDA DES 13017 (for plant manufactured prior to 1 January 2007) must conform to the requirements of AS3584.2:2008, Clause 2.6.3 Open Joints, which is a maximum gap of 0.2mm.

Feeler gauge inserted into gap as shown.
Measurements to be made at multiple positions
around Housing-Element circumference.

Specified Gap = 0.2mm Maximum

Any Gap in excess of 0.2mm constitutes an out of specification assembly.

Feeler Gauge Test: Check and record maximum gap between the Flametrap Housing and Flametrap Element. The maximum allowable gap is 0.2mm at any one point.

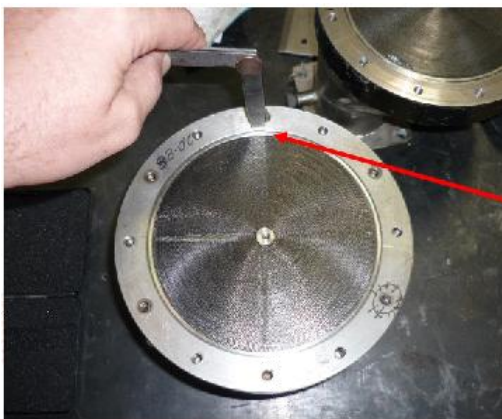
Feeler gauge inserted into gap as shown. Measurements to be made at multiple positions around Housing-Element circumference.

Specified Gap
0.4mm Maximum

Any Gap in excess of 0.4mm constitutes an out of spec. assembly.

Feeler Gauge Test: Check and record maximum gap between the Flametrap Housing and Flametrap Element. The maximum allowable gap is 0.4mm at any one point.
