Technical Bulletin / Safety Alert

Unique ID No: GEN2008-TBSA-01

Subject: Failed Door Latch Interlock Valve due to incorrect Interlock valve fitted

Applicable to: All JUG-A-0 UL/UV machines

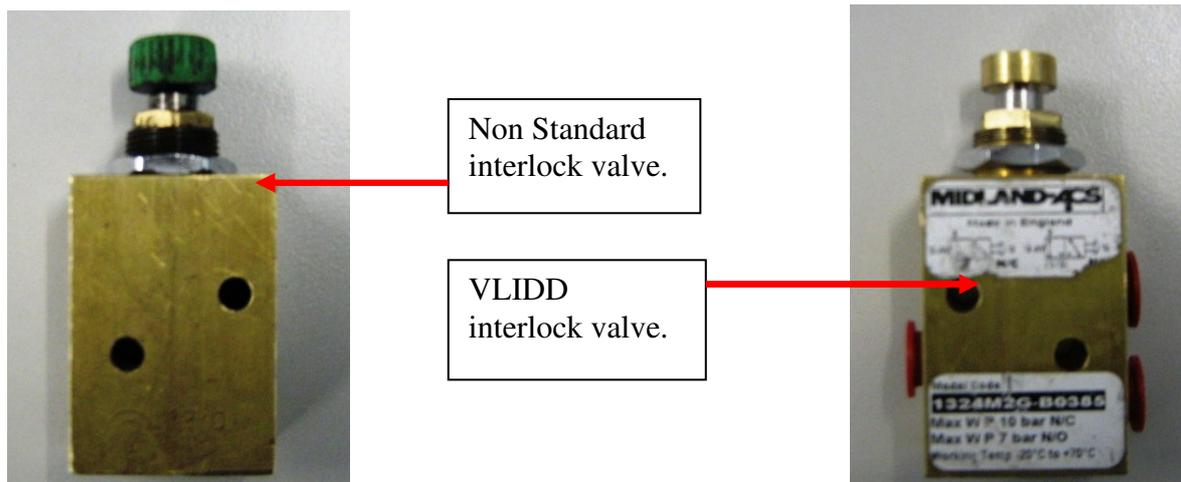
The first notable item was that the incorrect door interlock valve was fitted to the Door latch. A Non Standard valve had been fitted at some time. The Non Standard valve has a different style plunger on the top compared to the correct VLIDD valve, which when fitted to the Door Latch makes the valve about 4 mm longer. The extra length of the plunger hinders the ability of the valve to exhaust the air from the Park Brake valve.

Also the door interlock valve plunger was riding up out of the heel of the machined recess in the Door Latch pin. This would happen when the plunger travelled through the radius section of the recess.

This would cause the plunger to move into the depressed state, simulating that the Door Latch was closed again. This was evident as a track mark was worn out of the recess on

the outer radius. This only happened when the Door Latch was rapidly moved to the unlatched position.

To correct this fault a new Door Latch assembly and interlock valve was fitted to the machine.

- 1 x Door Latch assembly.
- 1 x Door Latch Plunger assembly.
- 1 x Door Latch Interlock valve.
- Correctly adjusted the valve to exhaust as soon as the plunger drops into the recess.

Only use the correct VLIDD parts when replacing faulty or worn parts.
