Technical Bulletin / Safety Alert

Unique ID No: GEN2009-TBSA-03

Subject: Possible Oil Injection Occurance

Applicable to: All Machines (occurred on JUG-A-0 UL/UV)

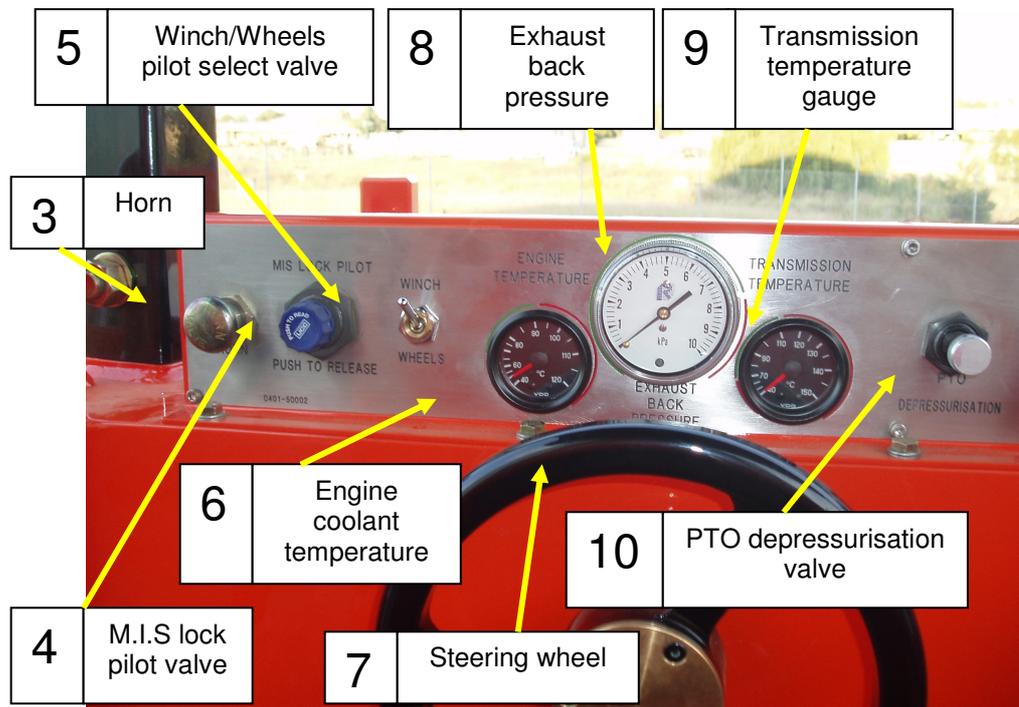
10. PTO Depressurisation Valve

By pushing this valve once the engine is stopped, both the front and rear 3/4" PTO hydraulic hoses are bled of any stored hydraulic pressure. This will enable easy changing of the PTO hydraulic quick couplers.
