Technical Bulletin / Safety Alert

Unique ID No: GEN2010-TBSA-01

Subject: Refurbished Steering Arm Failure

Applicable to: Refurbished Steering Arms on Dana Axles model No. 278 & 211.

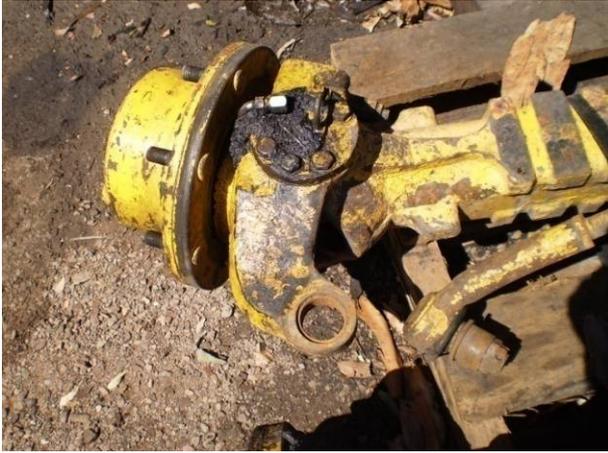
- The initial inspection revealed steering control had been compromised due to failure of a refurbished steer arm which retains the ball joint/tie rod assembly. As a result of the dislocation the tie rod shaft was also damaged.

Dislocated left hand side steering arm and tie rod linkage.

- All Driftrunner steer axles should be inspected for steer joint integrity.
- Axles identified with refurbishment bushes installed in the steer arms should replace the existing retaining nut with the new flanged retaining nut and split pin arrangement. The nut (Part No. 5-04235601) should be tensioned to 260-290Nm (192-214 ft-lb) and lock split pin installed.
- For existing steer assemblies a hole may be required to be drilled through the ball joint for fitment of the split pin. The flanged retaining nut should be correctly tensioned and opposing slots in the castellated flange nut used as a drill guide. Drill 5mm diameter hole halfway through threaded shaft and through from opposing side. The split pin should then be installed.

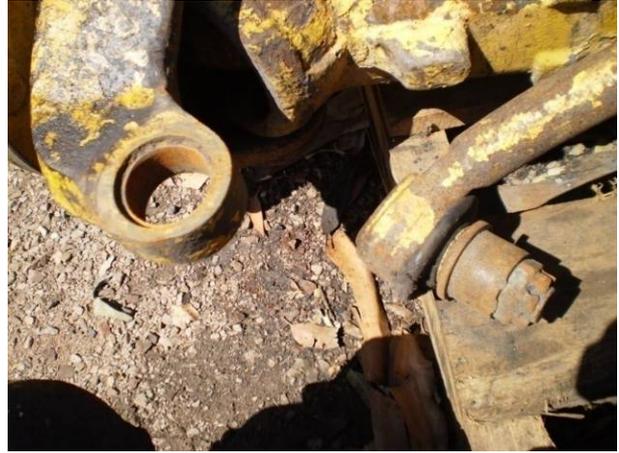
Enlargement of the dislocated steering components

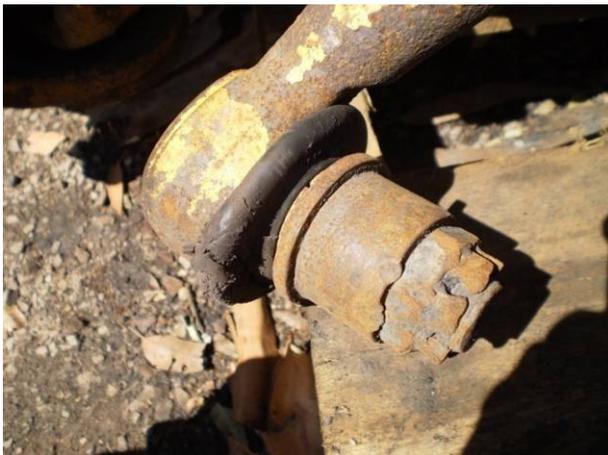
- The steer arm had been refurbished through fitment of a machined bush. Internal records did not identify a date of modification.
- As shown in the photos below the bush has a flanged lip on the top outer edge with mating recess machined into the upper surface of the steer arm.
- The retaining nut is visibly smaller than the outside diameter of the bush and no washer is evident.

Flanged bush still fitted to the ball joint

- In this configuration the ball joint/tie rod assembly has relied solely on the interference fit of the bush in the steer arm.
- A breakdown of the bush/arm joint has resulted in the bushed assembly being dislocated from the steer arm.

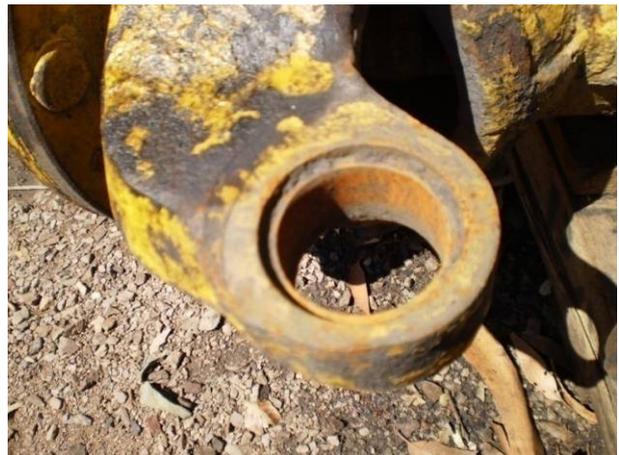
Machined recess in steering arm

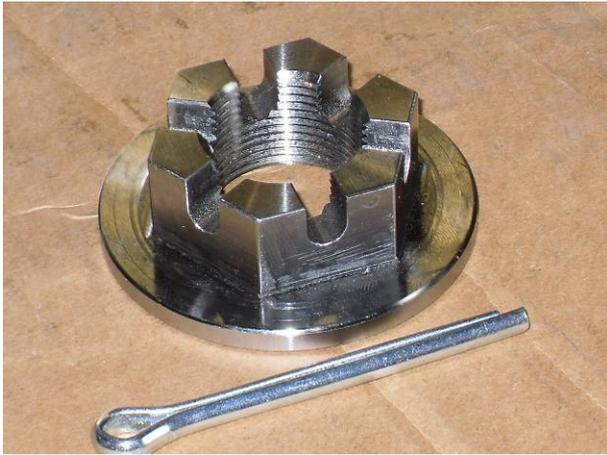
Flanged nut and lock split pin

- VLI Diesel have developed a flanged nut and split pin arrangement that effectively retains the ball joint in the steer arm and eliminates the need to fit a washer. The flanged nut and split pin are suitable for use on both new and refurbished steer arms.

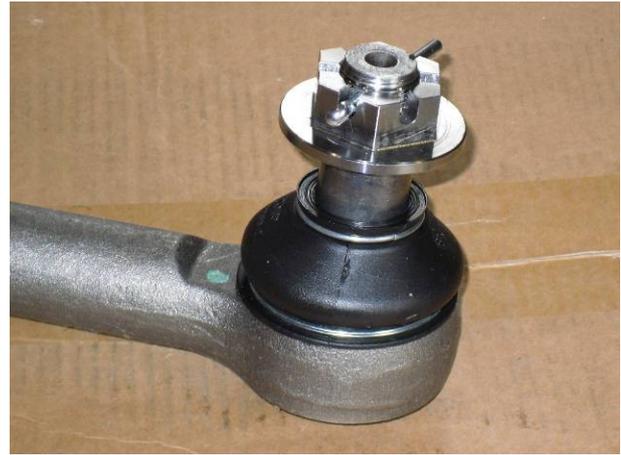
Flanged nut fitted to a new ball joint/ tie rod
