## Technical Bulletin / Safety Alert

**Unique ID No:** TBS2009-TBSA-02

**Subject:** Failure of JUG-A-0 UL/UV brake pedal linkage

**Applicable to:** All JUG-A-0 UL/UV machines

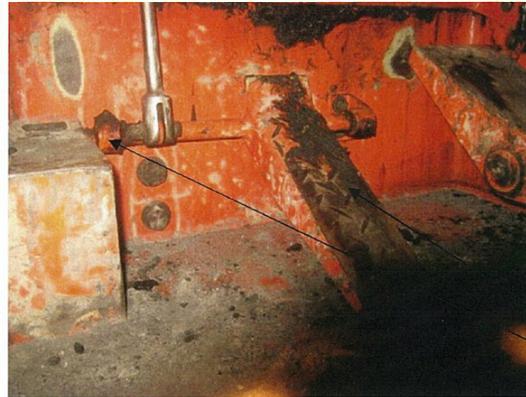
*Inspection of the brake linkage revealed that the mounting pivot boss had broken rendering the activation of the service brake ineffectual. The machine was immediately placed out of service pending a detailed investigation*

*Brake pedal assembly- arrow points to broken pivot boss on brake pedal.*

Inspections must be carried out on all pedal assembly's to ensure that the boss & link arm are fully welded. Below is an example of a properly constructed linkage:-

It is also recommended that the pedal to shaft assembly & R/H pivot boss assembly weldments be inspected & repaired/replaced as required.

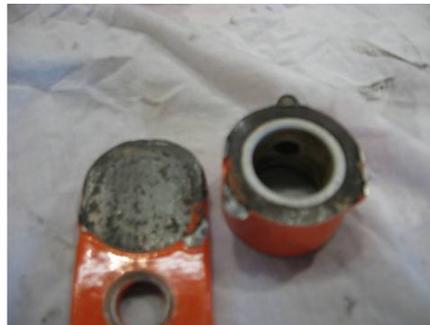
*The detailed investigation revealed that at the time of manufacture the pivot boss had only been tack welded. The full, final weld had not been completed*

*Detail of broken pivot boss showing only two "tack" welds with no weld penetration.*

The investigation of the failed components has shown an issue with the welding carried out to join the boss to the link arm.
